THE FOUNDATIONS OF THE NEW CROTON DAM.

BY CHARLES S. GOWEN, M. Am. Soc. C. E.

PRESENTED FEBRUARY 21ST, 1900.

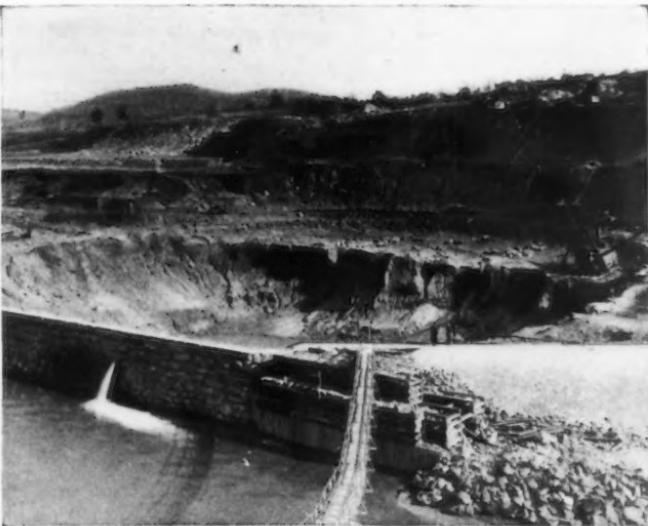
Fig. 1, Plate XXXVI, shows a part of the river wall and lower wing-dam, and the progress of the main dam excavation to September, 1895. The large pit shown was excavated mainly by means of the dredge, shown on the extreme right, with considerable assistance from the cableways, for which the material was excavated by hand into large

scale pans, and hoisted and transferred to the foot of the heavy slope shown in the rear, where it was dumped into cars. The levels above the pit, shown in Fig. 1, Plate XXXVI, were excavated with steam-shovels, and later, as further progress was made into the hard material of the great slope at the south end of the cut, steam-shovels were again placed at a lower level in the pit and the inclines were used as mentioned previously. Fig. 2, Plate XXXVI shows more particularly the steep slopes in the hardpan as finally shaped, and Fig. 1, Plate XLV shows in a more general way the side slopes, but at some time after the excavation was completed, when a small amount of back-filling had been done. Also, at this time, cuts had been made in the side slopes, forming berms on which side tracks were laid, to furnish supplies for the foundation masonry. Fig. 2, Plate XXXVI, shows particularly the hardpan slopes ($\frac{1}{2}$ horizontal to 1 vertical) and berms at the south end and on the quarters, as well as the underlying rock bottom excavated for the foundation masonry.

FIG. 1.—FEBRUARY 7TH, 1896. VIEW FROM UPPER END OF FOOT-BRIDGE, LOOKING S. E.
FLOOD IN FOREGROUND.

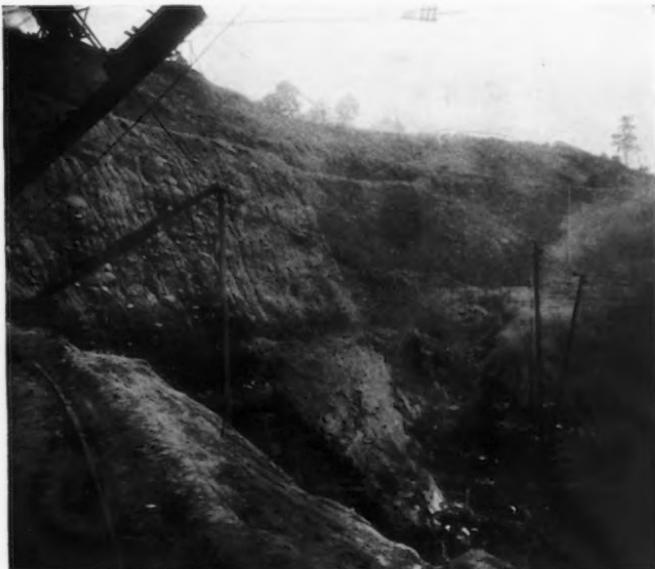
FIG. 2.—OCTOBER 1ST, 1897. SLOPE AND BERM AT SOUTH END OF CUT.

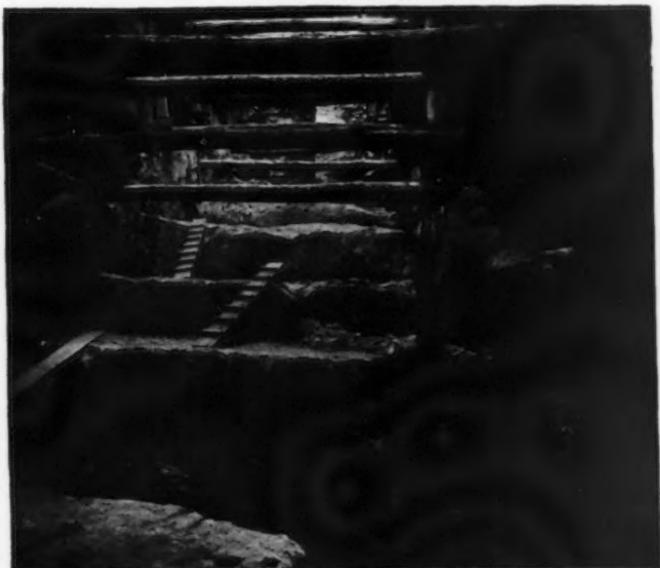
XXXVII, shows the rock bottom ready for the masonry of the core-wall, as well as the sheeting and sides of the trench for a certain distance up, at Station 1 + 80, 150 ft. from its junction with the main dam. At this point the rock was sufficiently compact and of necessary bearing strength, although not very hard, and the steps shown in the inclined surface of this foundation were made with picks and shovels. The depth to which the rock was excavated varied from 4 to 7 ft.

FIG. 1.—MAY 27TH, 1897. STEPPING AT BOTTOM OF CORE WALL.

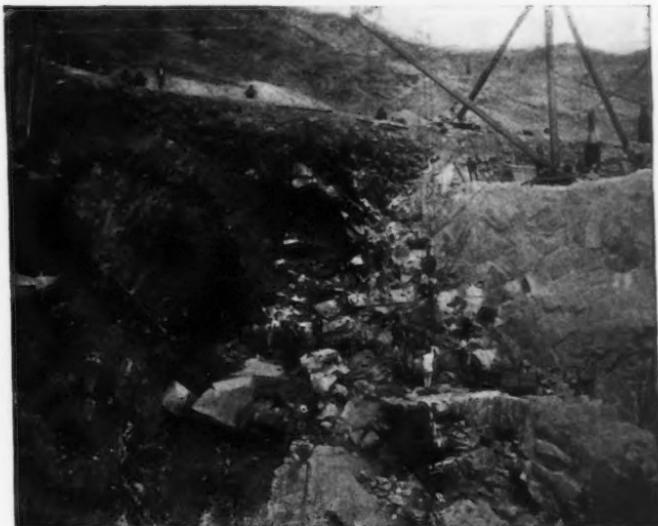
FIG. 2.—MAY 26TH, 1896. LAYING FIRST STONE IN DEEP ROCK CUT.

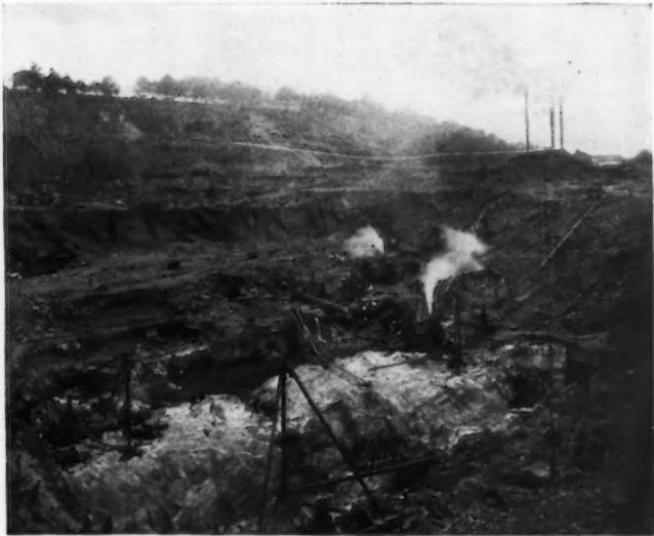
FIG. 1.—MAY 25TH, 1896. MAIN DAM EXCAVATION, LOOKING SOUTHWEST.

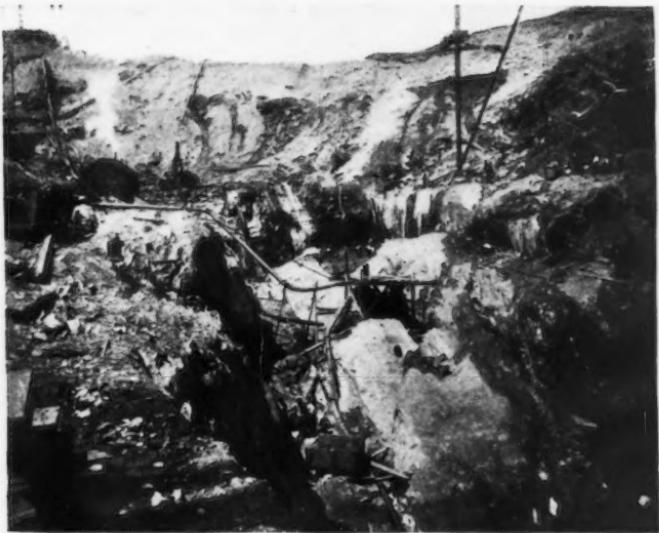
FIG. 2.—MAY 10TH, 1896. MAIN DAM EXCAVATION. DEEP ROCK CUT, LOOKING WEST.

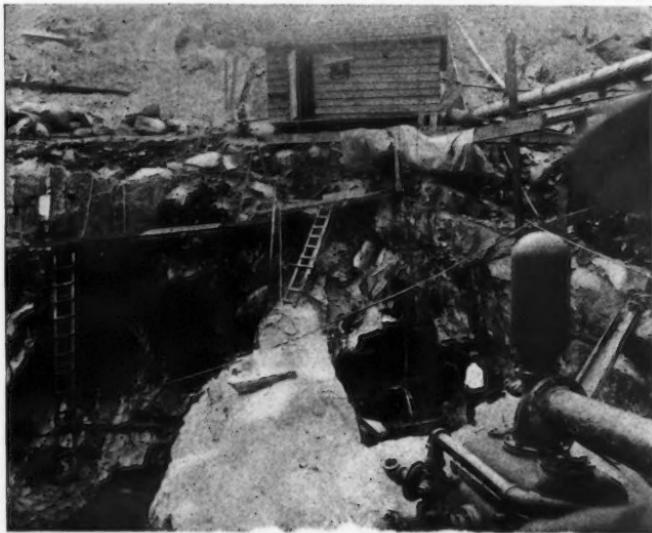
A well-defined narrow seam along Station 7 + 70 is illustrated by Fig. 1, Plate XL, showing its down-stream end. Its up-stream end

FIG. 1.—SEPTEMBER 1ST, 1896. MAIN DAM EXCAVATION, LOOKING WEST.

Between Stations 7 + 30 and 7 + 60 is shown a narrow well-defined seam of hard rock with many erosions connected and extending to the deeper holes excavated at the ends. Fig. 1, Plate XL, shows on the left the deep excavation on the down-stream end. Beyond this seam lies a compact seam of friable limestone about 10 ft. wide. It is shown in Fig. 1, Plate XL, on the extreme left, where the ladder is resting against it, when the excavation was completed. It was tested for bearing strength by an apparatus shown in Fig. 10. This apparatus consists of a cylinder to be loaded with shot necessary to produce the required pressure upon its bearing point, a circle $\frac{1}{4}$ in. in diameter. This was applied carefully and repeatedly to the surface in question at different points, and the results indicated that the bearing power of the surface was ample up to the limit of the test, which was 250 lbs. to the square inch.

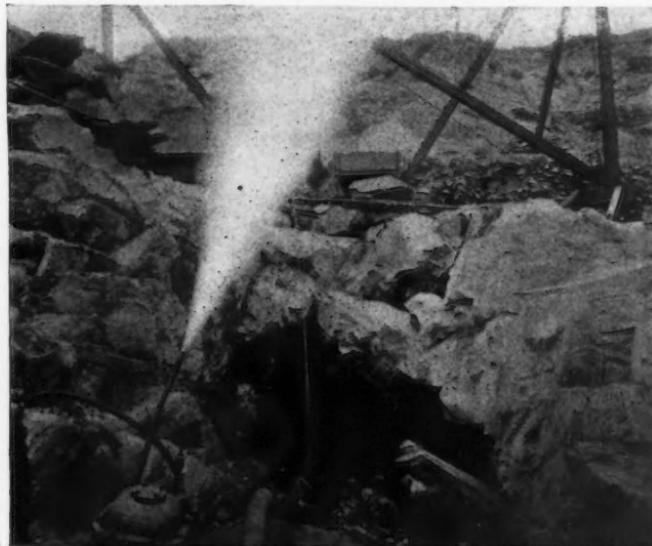
FIG. 2.—SEPTEMBER 12TH, 1:16. CAVE AT STATION 7 + 70, 10 L.

developed upon excavation into the cave previously referred to. Fig. 2, Plate XL, shows the cave opening at Station 7 + 70, 25 L. The pump and suction hose in use are also shown. This suction hose and another line, of the same size, were built in the masonry when the tunnel was filled up, in order that the necessary drainage from a sump hole, placed outside of the upper line of the dam in the lowest point of the tunnel reached, might be maintained. The length of the cave excavated and filled as tunnel was about 30 ft. The floor is of very hard and solid rock; holes traced 16 ft. deep found no openings below. The masses of rock on the top and sides are all solid, showing few or no open seams, except that the seam between the cave floor and the right side wall may have had an open connection with the low point in the excavation at Station 7 + 35, 15 R., where, in grouting, later, there were some indications of an open passage between the points in question. As this was indicated by the pump from the sump at Station 7 + 62, 25 R., throwing out grout which was being pumped in at the point noted, it is not at all certain that the line of communication between the two did not lie mostly outside the dam foundation.

cement grout mixed with fine sharp sand of 1 to 1 or 2 to 1 mixture according as the grout was pumped or poured. In the case of the "cave," rubble masonry in mortar was used as filling in the large opening, while in some smaller erosions the spaces were thoroughly packed with small stones before the grout was poured in, and, in one or two exceptional cases, American cement was used for the grouting.

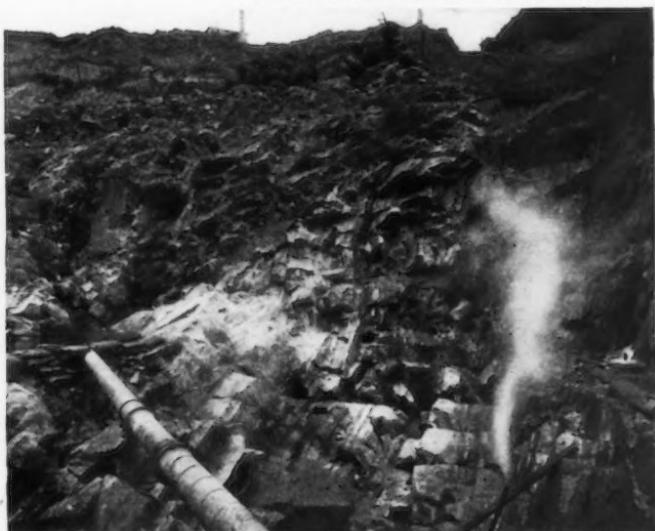
FIG. 1.—NOVEMBER 20TH, 1896. MAIN DAM EXCAVATION. ROCK FACE, UP-STREAM SIDE.

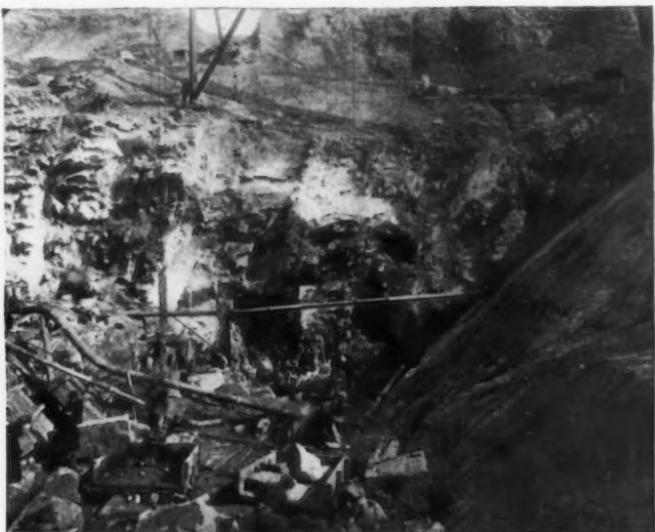
The sloping bed of rock shown in Fig. 2, Plate XLI, extends quite across the dam; and beyond it, to Station 5 + 40, lies a hard bottom, reasonably free from seams and erosions, and calling for but little excavation. Between Stations 5 + 30 and 5 + 40 occurs a deep, well-defined seam, or series of erosions, shown at the upper end in Fig. 1, Plate XLIII. This photograph shows also the general character of the rock bottom on both sides of this seam, and Fig. 2, Plate XLIII, and Fig. 1, Plate XLIV, show it still further to the south, and to the junction of the main dam with the core-wall. This part of the bottom

FIG. 2.—FEBRUARY 26TH, 1897. MAIN DAM ROCK EXCAVATION AND MASONRY.

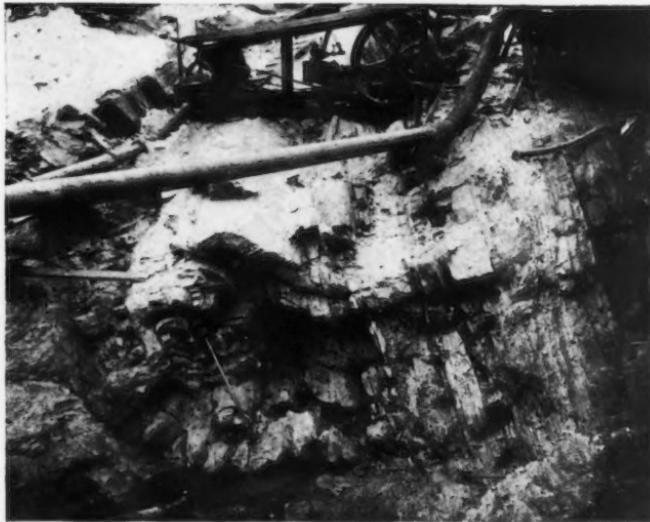
FIG. 2.—FEBRUARY 17TH, 1897. ROCK BOTTOM AND EROSIONS.

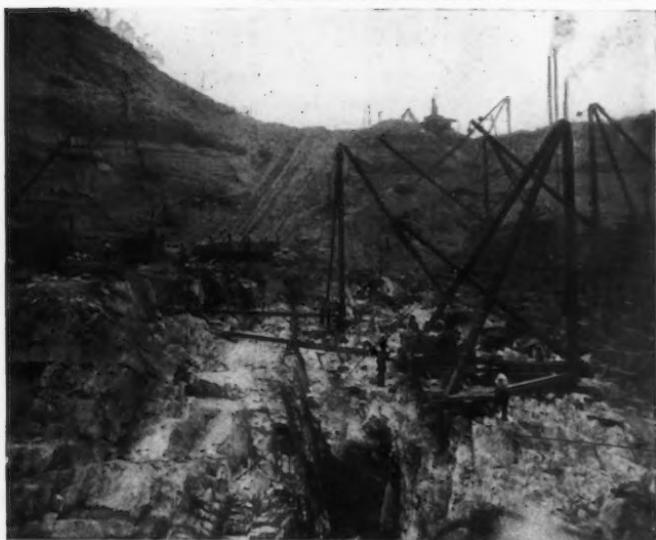
FIG. 1.—JUNE 27TH, 1897. ROCK BOTTOM, SHOWING ERODED SEAM.

But little grout was used beyond this bottom until the eroded seam between Stations 5 + 30 and 5 + 40 was reached, as the spring hole at Station 5 + 93 was not treated by grouting.

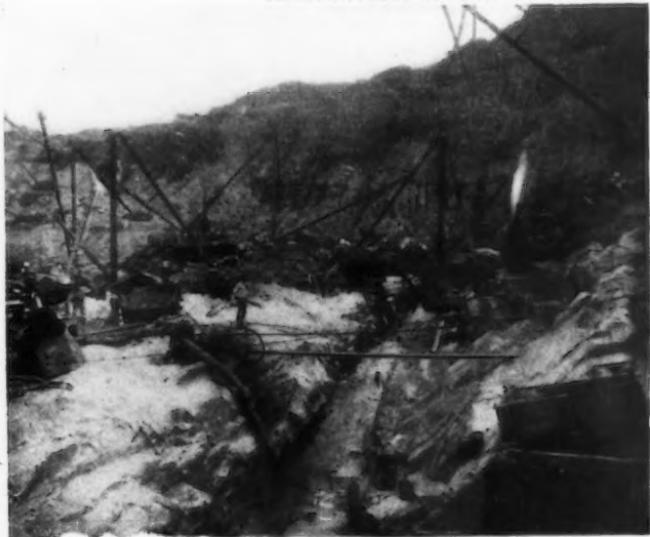
calls for little comment, although a seam showing at Station 4 + 60, and extending partly across the foundation, is shown nearly ready for masonry in Fig. 1, Plate XLIV.

FIG. 1.—AUGUST 10TH, 1897. SEAM AT STATION 4 + 55, LOOKING EAST.

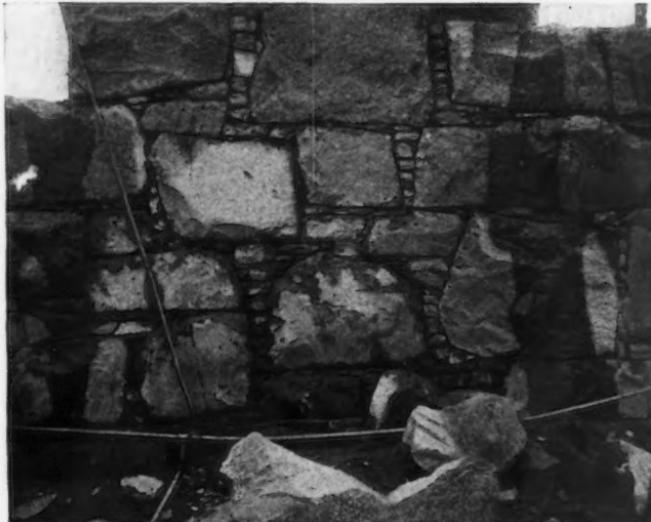
FIG. 2.—JUNE 22D, 1898. UP-STREAM SIDE, STATION 8 + 70 ±, SHOWING JOINTS RAKED OUT FOR POINTING.
